AA TRUCK TALK - 242-A HEAVY DUTY EXPRESS BODY

By Neil Wilson of Boulder, Colorado – April 2013

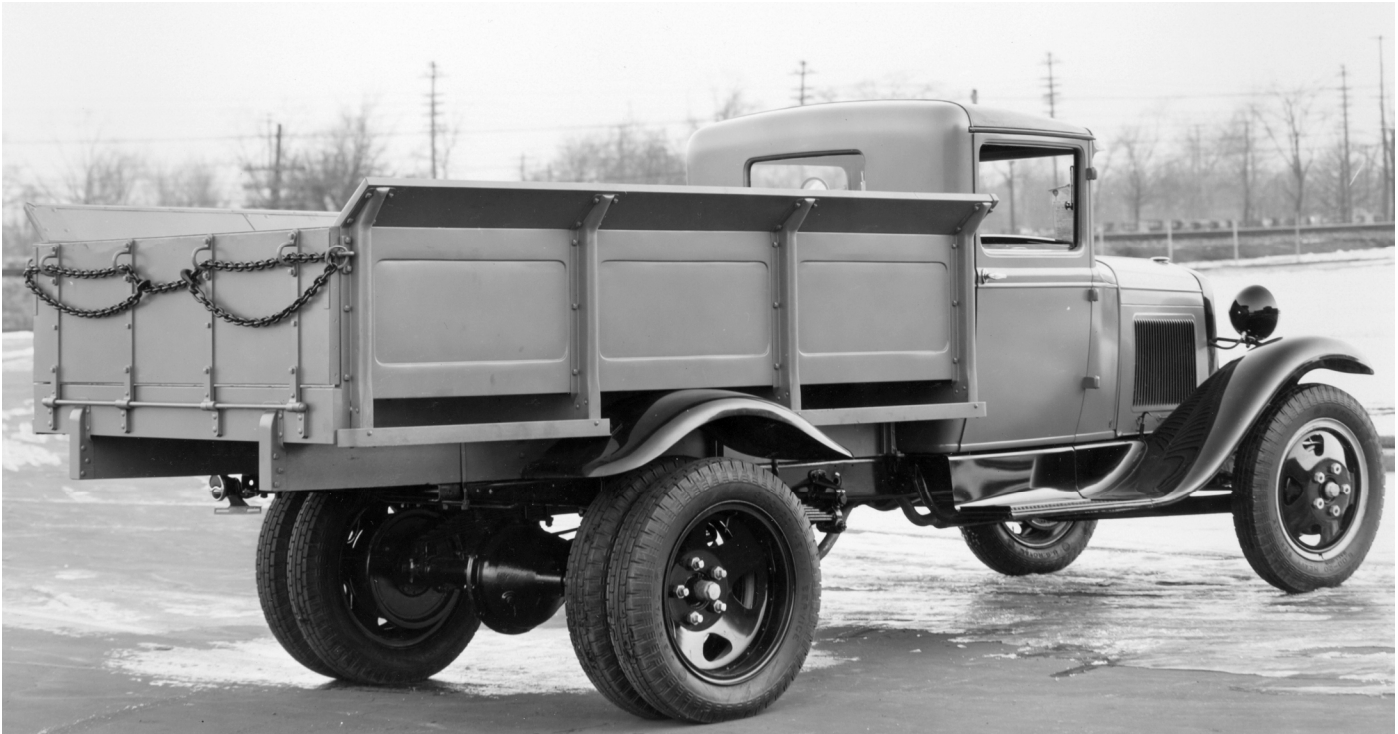
Figure_{242A}04 - 242-A HD Express Truck - Early 1931

Typical HD Express Truck: Figure_{242A}04 shows one of the first HD Express trucks off the assembly line. This truck has the pre-April frame and the initial tail gate chain design. These

trucks came standard with dual rear wheels and unique rear fender as shown. Fenders, aprons, head lamp cases, and radiator shell are bright enamel due to the dipping process used for these parts.

Note the light color on the hood, cab, and cargo body which was not polished (a standard finish for the commercial line). The cargo body was painted after assembly (inside, outside, and bottom) all the same color with a satin enamel to maintain the same finish as the pyroxylin lacquer used on the cab and hood. Also note that the rear u-bolt shows it was painted body color from the frame up (not a standard production feature).

The four side braces and the three side panel (with recessed stampings) can be seen. The tail gate panel is flat with no stamped recesses. Both sides of the flare assemblies can be seen.

The chassis is “all black” with no plated hardware showing. This is due to the “assembly line painting” operation which covered otherwise plain and plated parts. Even the rear backing plate brake adjusting wedge is covered with black paint. The backing plate was installed after the “assembly line painting” operation.

The wheels are the 1930 thru early 1931 design with a dipped black enamel finish. The wheel lock rings, wheel nuts, and hub caps were cadmium plated.

The tail gate used an initial 128-21/31" long chain fed through rings and loops as shown in figure_{242A}04. In March 1931 a new design started production using short side chains which hooked to eye brackets attached to the tail gate (basically the same design as the 89-A express and 78-A pickup bodies).

At the top of each side was a 7-11/16" wide flare assembly (supported by the four side braces) with a 47.6° angle. This gave the body its overall 73" width. The outside face of the flare assembly was a metal panel as shown in Figure 242A04. Figure 242A10 shows the flare panel from the inside (the wood is mostly gone).

This assembly also consisted of a metal outside panel lined with 1" thick boards. The tail gate had four outside strap hinges with skid strips on the inside to allow loading of cargo with the tail gate lowered. An angle iron edge strip framed the top and side edges to conceal the panel flanges and edges of the boards. Figure^{242A12} shows the tail gate assembly (rear and inside views). The chain and eye bracket assembly is the second design which started production in early 1931. Figure^{242A04} shows the first design chain arrangement.

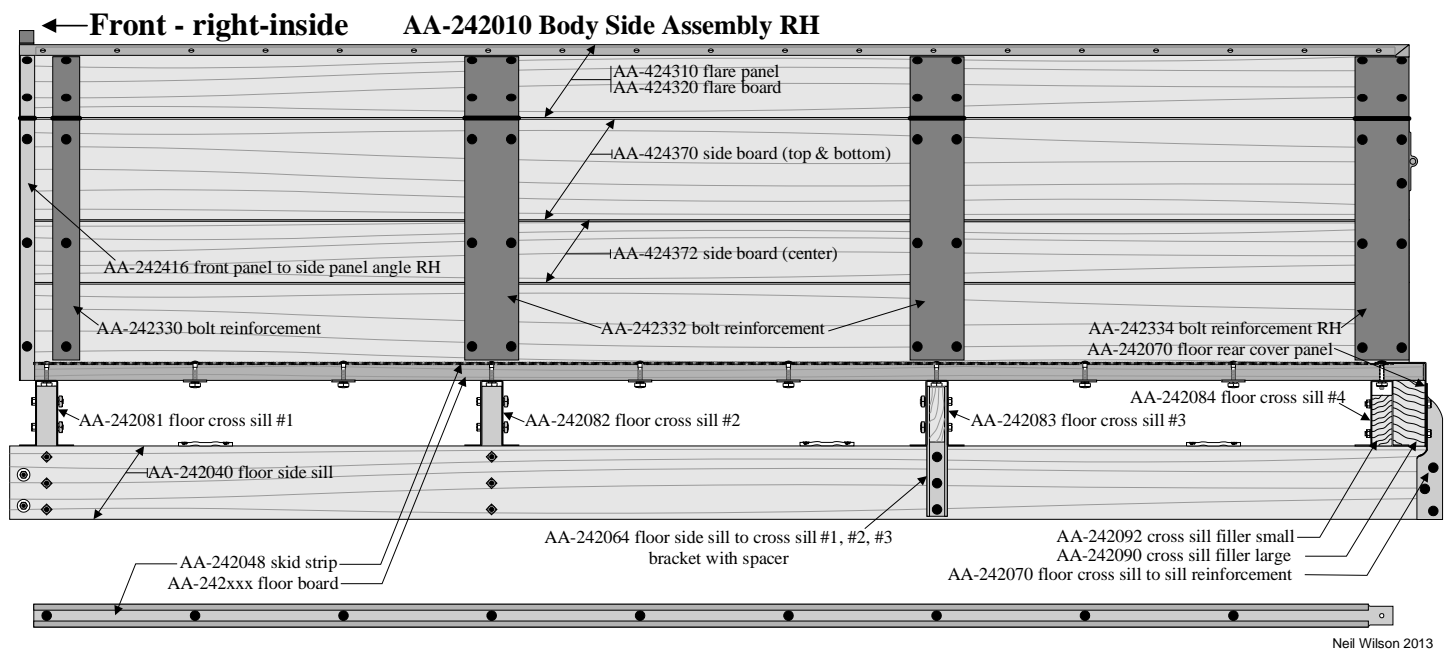
Figure 242A09 - 242-A Side Assembly - Inside View

Figure 242A09 shows an inside view (right side) of a side assembly lined with 1" thick boards (including the flare assembly). Flat steel bolt-reinforcement plates were located at each side brace to prevent carriage bolt heads from sinking into the boards. The same set of board was used on both side assemblies. An enlarged end view of the shiplap boards is shown in figure 242A11

The flare panel wrapped to the top face of the flare board and was secured with oval head, slotted wood crews.

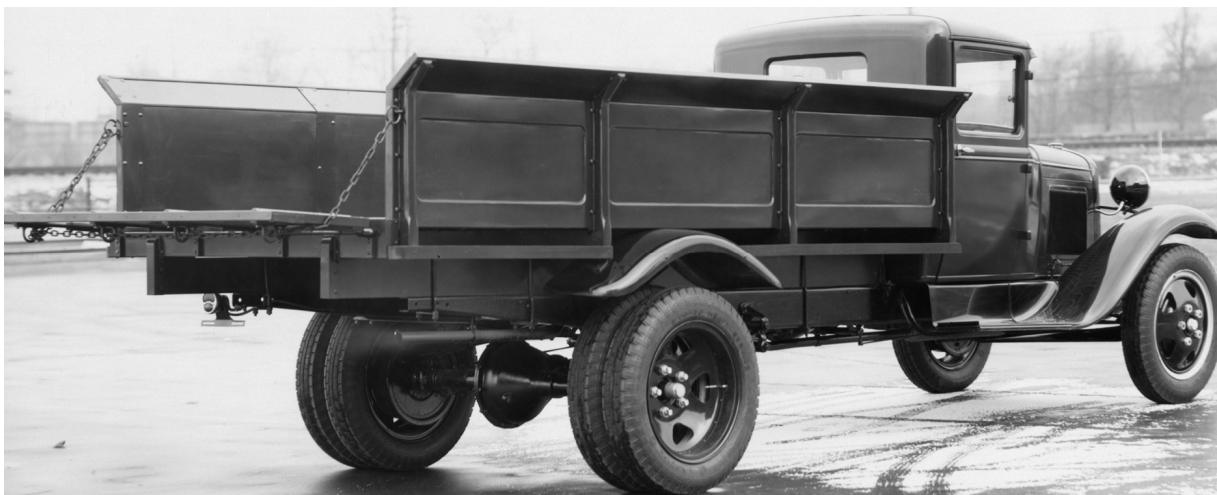
Prototype AA157 HD Express

This body type was never released for production. A number of design differences can be seen.

- Solid interior side wall
- Rear fender edge bolts and different bracket
- Rear reinforcements with only two bolts
- Different body tail gate hinges

The light duty 1931 express bodies (195-A and 197-A) were production body types for the AA131 and AA157. Ford entertained the production of an AA157 heavy duty express and a prototype was produced and photographed (shown at the end of this article). However, this body type was not added to the production line.
